Stability analysis and treatment scheme of unstable slope in Tianshui Majishan International Center

Abstract: through the field investigation of the slope of Majishan international camping center in Tianshui, the deformation and failure characteristics of the slope are analyzed; Combined with geotechnical engineering exploration technology, the deformation and failure mechanism of the landslide in the international center is discussed; The stability of landslide is analyzed by transfer coefficient method. The results show that the landslide of Majishan International Center in Tianshui is induced by earthquake and belongs to earthquake rainfall coupling landslide. The landslide mass is relatively stable in natural state. Under rainfall and earthquake + rainfall conditions, the unstable slope is in an unstable unstable state. The landslide is treated by “anchor cable frame + slope toe retaining wall + peripheral drainage channel”. The research results can provide practical basis for the deformation mechanism and disaster prevention and mitigation of earthquake induced landslides in Maiji District, Tianshui.

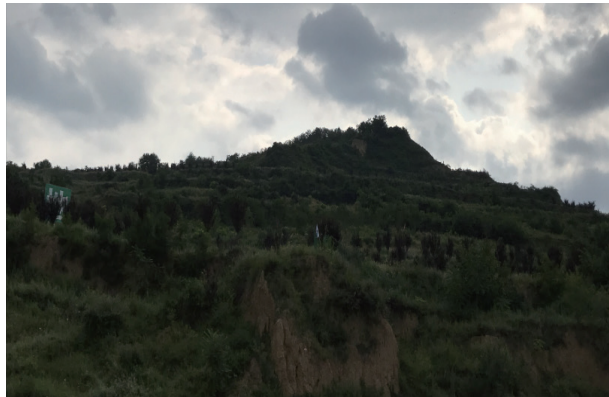
Figure 2-1 overall basic characteristics of H1 landslide

According to the field survey, there is an old landslide H1 in the loess hilly slope in the southeast of the proposed site. The landslide is irregular “dustpan shaped”, with obvious high-level pull marks on the rear wall of the landslide, and the slope body is in the East— in the west direction, the slope aspect is $250^\circ - 255^\circ$, the overall slope is $10-30^\circ$, the slope surface is stepped, the width of the steps is 5.0 ~ 15.0m, the longitudinal length of the landslide is about 280 ~ 320m, the average width is about 145m, the average thickness of the landslide is about 15m, and the landslide volume is about $65.3\text{m} \times 104\text{m}^3$, belonging to medium-sized landslide.

The field survey results show that the H1 landslide accumulation body is mainly composed of loess, mudstone and gravel. The loess is light yellow and yellow silty clay and silt, and the brownish red mudstone is mainly in lumps, mixed with calcareous and argillaceous nodules, which are unevenly distributed, with a layer thickness of 1.2-5.5m. The Neogene mudstone has low diagenesis and poor water permeability, which is easy to collect water and soften with water, reducing its strength. It is comprehensively determined that H1 landslide is an earthquake landslide, which is mainly reflected in: 1) the rear wall of landslide slope is high. The high tension surface is located at the top of the slope, which is formed by the overall downward displacement of the soil at the top of the Loess beam; 2) The stratigraphic sequence is disordered. The seismic landslide has large kinetic energy and long sliding distance, which makes the gravel layer and maroon mudstone appear intermittently in clusters, and the mudstone occurrence angle is 4-10 ° greater than the regional contact angle; 3) The slope platform is stepped. The non-uniform propagation of seismic wave causes the shear failure of some soil near the slope. Under the action of seismic wave vibration, the slope soil is loose and piled up, and the cracks are developed. Under the later weathering, frost heaving and hydraulic erosion, the slope is fragmented, forming numerous rills and tributaries. Under the action of short-term concentrated rainfall, it is easy to destabilize and damage again, such as the formation of secondary landslide. According to previous studies of domestic scholars, the damage of loess slope induced by rainfall is mainly manifested in: 1) the surface water infiltrates into the interior of loess body, increasing its weight, increasing its sliding force, softening the soil body, and reducing its shear strength; 2) Water infiltrates along the joints and fissures of soil mass, and the intervention of water reduces the effective stress and forms a weak channel; 4) The groundwater is recharged by the infiltration of surface water, resulting in the buoyancy effect on the rock and soil mass.

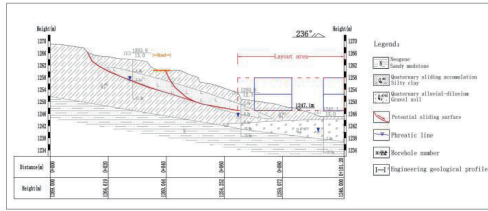
Figure 3-1 typical engineering geological map of BW1 slope Figure 3-2 typical engineering geological map of BW2 slope

Bw1 unstable slope is developed at the foot of the Yingchuan river terrace slope on the north side of the commercial street, and is distributed in an “armchair” shape as a whole. According to the planning, it needs to occupy the site at the foot of the slope, with a longitudinal length of about 27m and a width of 143m, resulting in a 4-9m high slope. The total plane area of the slope is about 4438m², and the slope aspect is 236-266 °. At the top of the slope is a landscape Avenue with a planned width of 6m, and at the foot of the slope is a campsite business street, mainly with 2F pavement.

The material composition of bw1 unstable slope is mainly composed of landslide accumulation layer containing sandy gravel silty clay, and the soil structure is loose. Two obvious deformation tension cracks can be seen at the slope village road. After the slope toe is artificially cut and reconstructed, the slope body is gentle up and steep down in a broken line shape, the front edge of the slope body is steep, the relative height difference of the slope body is large, and the free space conditions are superior. According to the engineering survey data, there is lenticular sand gravel layer in the middle and upper part of the slope toe, with a thickness of about 3.5m, an extension length of 47m and an inclination of 23 °, which is a channel for groundwater enrichment and transfer.

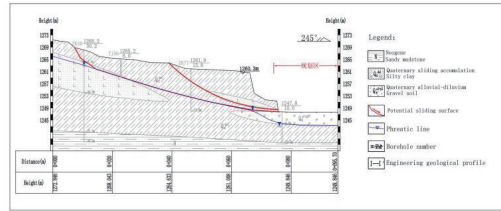
The BW2 unstable slope is developed at the foot of the Yingchuan river terrace slope on the north side of the dormitory building, and is generally distributed in a “strip” shape. According to the planning, it needs to occupy the site at the foot of the slope, with a longitudinal length of about 16m and a width of 94m, resulting in a 12-14m high slope, with a total plane area of about 1445m² and a slope aspect of 265 °. The top of the slope is a landslide platform formed by the old landslide, with a width of about 55m. At the foot of the slope is 4f dormitory building in the campsite.

The material composition of BW2 unstable slope is mainly the silty clay of landslide accumulation layer, and the soil structure is loose. According to the field investigation, no obvious deformation characteristics are found at the front and rear edges. After the slope toe is transformed by artificial slope cutting, the slope body is gentle up and steep down in a broken line shape, the front edge of the slope body is

steep, the relative height difference of the slope body is large, and the overhead conditions are superior. At the same time, according to the engineering survey data, there is lenticular sand gravel layer in the middle and upper part of the slope toe, with a thickness of about 2.0m, an extension length of 24m and an inclination of 18 °.

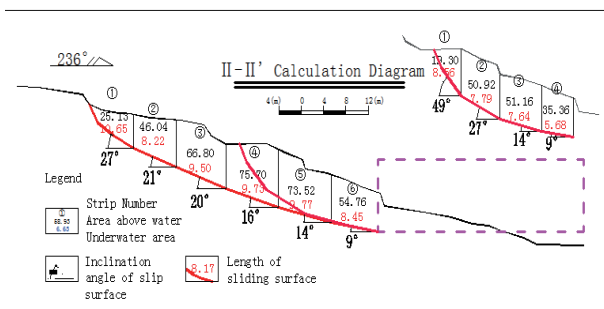
Figure 4-1 BW1 slope calculation model

The section II - II 'is selected to calculate and evaluate the stability of bw1 slope, and the section V - V 'is selected to evaluate the stability of BW2 slope. The potential sliding surfaces are broken line sliding of gravel layer and silty clay along the groundwater table and are sliding in silty clay layer.

Inversion value: according to the field investigation, the shallow layer (IV - IV ') of the current bw1 unstable slope has slipped. According to the exploration, the sliding surface is above the groundwater level. Therefore, the value of stability coefficient in the inversion

Disaster name	Section number	Calculation condition	Stability coefficient	stable state	safety factor
Bw1	IV - IV 'section	Working condition II	1.082	Basically stable	1.30
		Working condition III	1.045	Unstable	1.15
		Working condition IV	0.945	Unstable	1.15
BW2	V - V 'section	Working condition II	1.093	Basically stable	1.30
		Working condition III	1.053	Unstable	1.15
		Working condition IV	0.945	Unstable	1.15
	V - V 'section (shallow layer)	Working condition II	1.089	Basically stable	1.30
		Working condition III	0.097	Unstable	1.15
		Working condition IV	0.948	Unstable	1.15

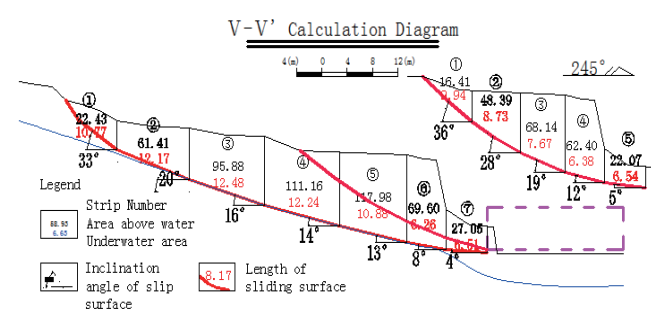
Figure 4-2 BW2 slope calculation model

process is as follows: restore the IV - IV' section of BW2 slope to the original ground, and the original slope shape is similar to the V - V 'section of BW2 slope, Under the condition of "self weight + rainstorm", the stability coefficient is taken as 0.98 to calculate its shear strength.
